Pedestrian-Vehicle Collision Posture Analysis Based on Pedestrian Lower Limb Injuries

ABSTRACT This study examines the role of pedestrian lower limb injury characteristics in analyzing collision postures in traffic accidents. A real case of a pedestrian-vehicle collision involving typical pedestrian injuries is selected, and the pedestrian's posture at the moment of collision is comprehensively analyzed using lower limb injury characteristics, traffic accident traces, and findings from the autopsy report on brain injuries. The results indicate that relying solely on the surface characteristics of lower limb injuries to determine the collision direction may lead to erroneous conclusions. While the analysis of lower limb surface injuries is of significant practical value for reconstructing accident processes and determining responsibility in road traffic accidents, it also provides important reference value for improving pedestrian lower limb safety. However, analyzing pedestrian collision postures based on lower limb injuries is a complex and challenging task. It requires the integration of multiple factors and information for thorough analysis and research.

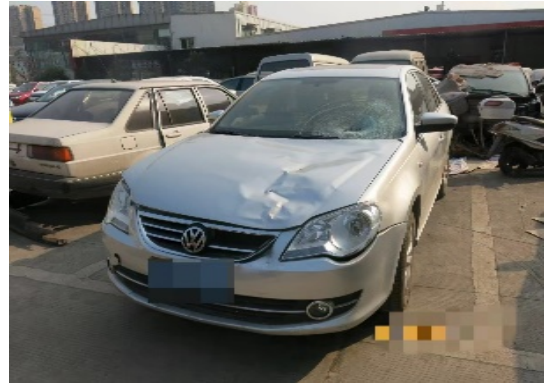
(a) Car body marks

The collision between the vehicle and the pedestrian generated various traces, as illustrated in Figure 2. Multiple contact traces were observed on the vehicle body, primarily concentrated on the windshield, hood, and front bumper. A wide circular area of damage was present on the front windshield, accompanied by visible hair residues at the fractured region. Additionally, the hood displayed a large area of concave deformation.

However, further analysis of vehicle traces and head injuries revealed additional insights. The injury on the right side of the pedestrian's forehead was caused by contact with the front windshield. The irregular crack observed below the right knee, located in a concave area of the body surface, was unlikely to result from ground contact. According to the autopsy report, the fracture of the tibia and fibula at the injury site, coupled with the formation of pseudoarthrosis, indicated that the wound was caused by puncture from the fractured ends of these bones. The irregular fissure below the left lateral malleolus, a convex area of the body surface, was likely caused by contact with the ground after the pedestrian's right side was struck.

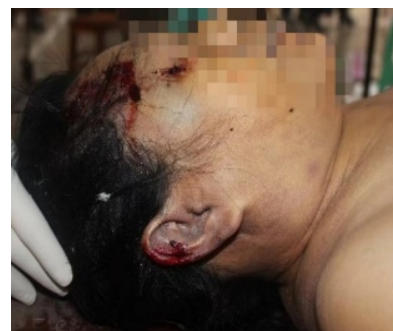
(a) the injury of the right head of the injured

The autopsy revealed several injuries sustained by the pedestrian. A wound was observed below the left lateral malleolus, accompanied by subcutaneous hemorrhaging on the outer side of the right calf. There was also a wound on the inner side of the right knee. The injured person exhibited prominent wounds on the right side of the forehead, while the left side showed no significant injuries.

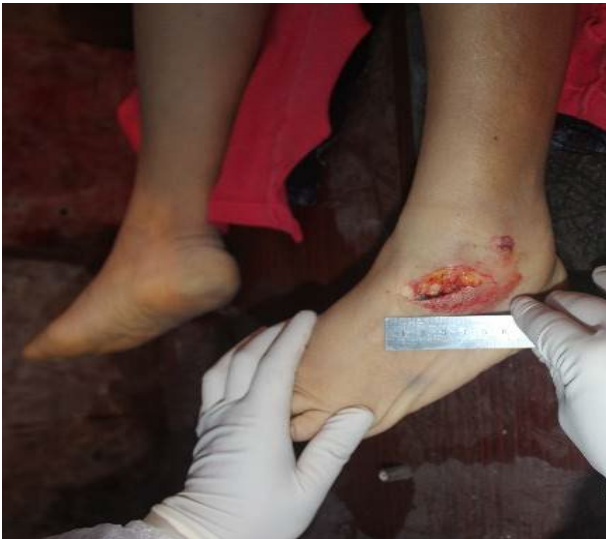
(a) Left lateral malleolus injury

Specific injuries included a 5.2 cm × 1.6 cm irregular tear extending into the tendon below the left lateral malleolus, and

The posture of a pedestrian in a traffic accident was analyzed based on the injuries to their lower limbs. Initial observations of wounds below the pedestrian's right knee and left lateral malleolus suggested that the pedestrian's left side was impacted, indicating they moved from the vehicle's right to its left during the collision.

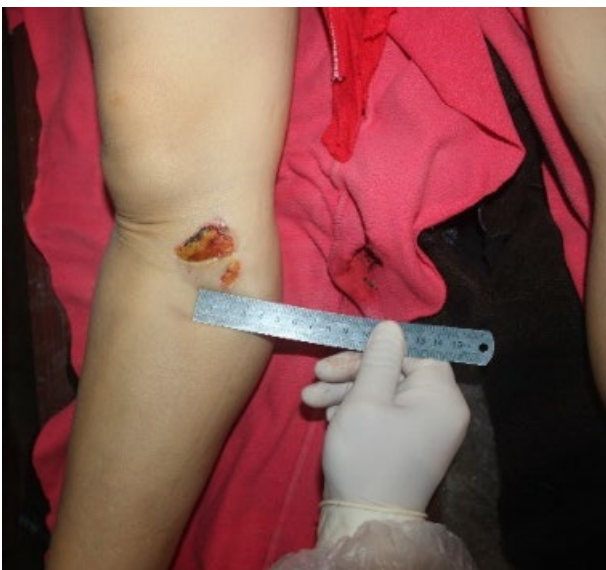
(b) Right knee injury

a 3.9 cm × 1.5 cm irregular tear extending into the tibia below the right knee. The corresponding tibia and fibula exhibited comminuted fractures consistent with the site of the wounds, forming pseudoarthrosis.

In this case, the irregular crack observed from the right knee to the tibia, combined with autopsy findings, indicated that the injury was caused by puncture from the tibia and fibula fracture ends. A comprehensive analysis of vehicle traces and the pedestrian's head injury supported the conclusion that the pedestrian moved from the left side of the vehicle's driving direction to the right. Lower limb injuries vary based on the specifics of each collision, and surface injuries alone should not be used to determine collision posture. Instead, lower limb surface injuries should be analyzed alongside fracture patterns and injuries to other parts of the body for a more accurate assessment.
